Axle Service Manual

100F Series Drum Brake

External Drum, 420mm x 180mm

80245 REV C

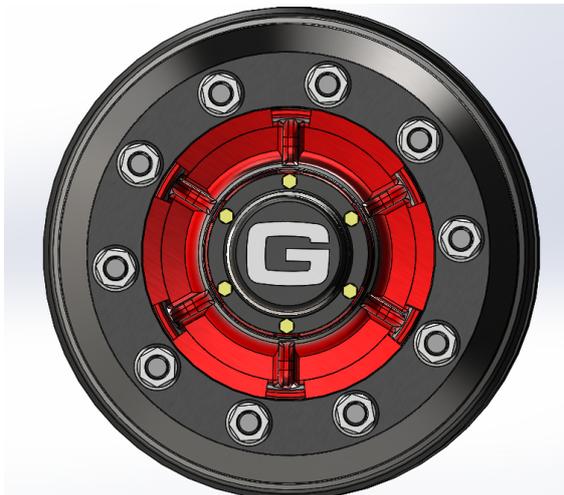
Hub cap is removed by removing the six retaining Bolts

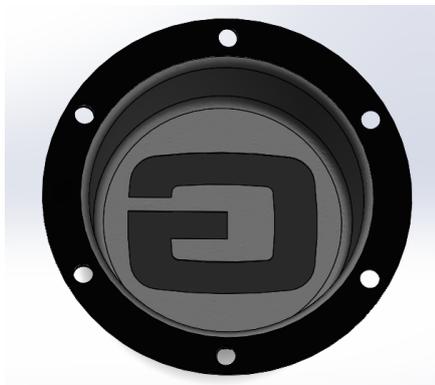
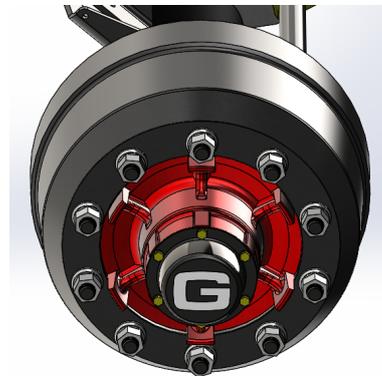
End float procedure when hub is fitted

- Fit the adjusting nut and torque to 373 Nm.
- Rotate the brake drum 4 times and re-torque to 373Nm.
- Loosen the adjusting nut by one full revolution.
- Torque the adjusting nut to 102Nm.

- Back off (Loosen) the adjusting nut 1 to 1.5 flats.
- Fit the lock washer so the dowel pin of the adjusting nut slides into one of the holes of the washer. If necessary flip the washer to achieve this alignment, or loosen half a hole.

- Fit the lock nut and torque it to 373Nm.
- Fold down two of the tabs on the lock washer, one at 12 o'clock and one 3 o'clock.
- Rotate the brake drum 4 times to test the functionality of the brakes.

- Manually rotate the camshaft and simultaneously rotate the drum to check.
- Clean the surface area of the end of the spindle.
- The above procedure is used to set the end float to be between 0.0254mm - 0.1016mm (1 - 4 thousandth inch). Ideally this should be confirmed using a dial gauge.

- Apply a small amount of grease to spindle end and hub cap. Fit the gasket and fit the hub cap bolts and torque to 20-25Nm.

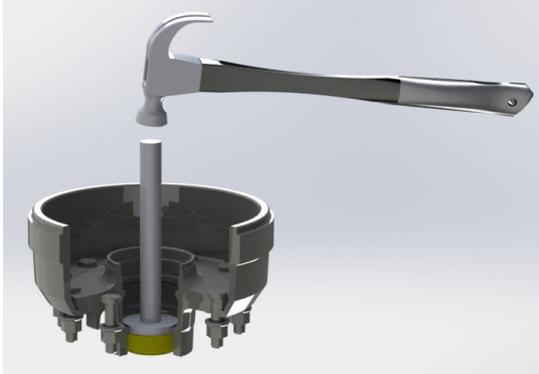
Outer bearing cone being removed.

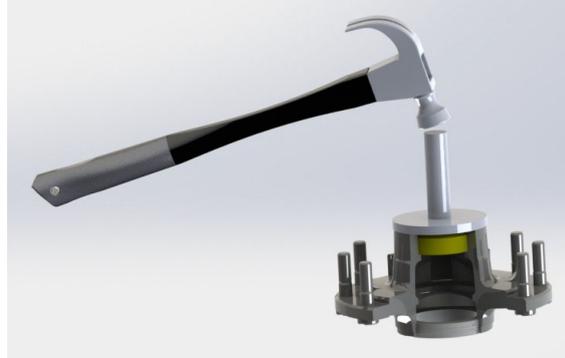
Outer bearing cone being fitted

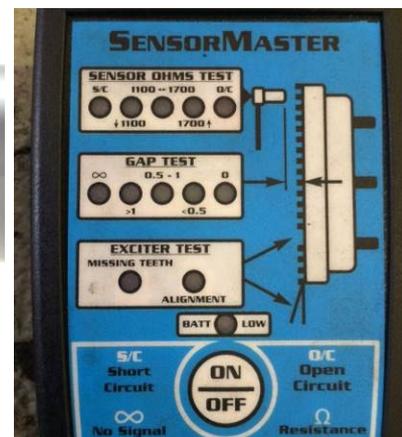
If the ABS pole wheel is being replaced or fitted, 100 tooth (Part no. 61789), it is important that it is fully seated on the hub and it is perfectly parallel to the hub face otherwise it will create an ABS fault reading. If replacing or changing the ABS sensor ensure it is properly coated with the supplied anti fretting paste.

Anytime an ABS axle is serviced the axle should be tested with an ABS testing device when reassembled.
