Axle Service Manual

300 Series Drum Brake

Internal Drum, 310mm x 190mm

*Updated: October 2020
80254 REV C*

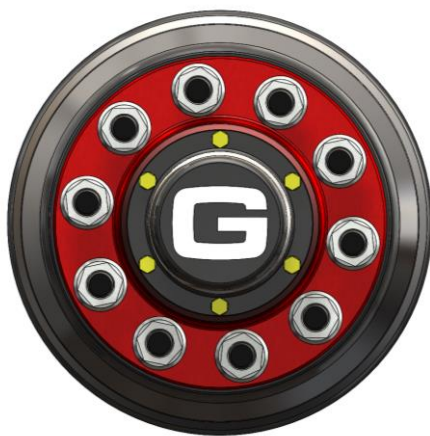
Hub cap is removed by removing the six retaining Bolts

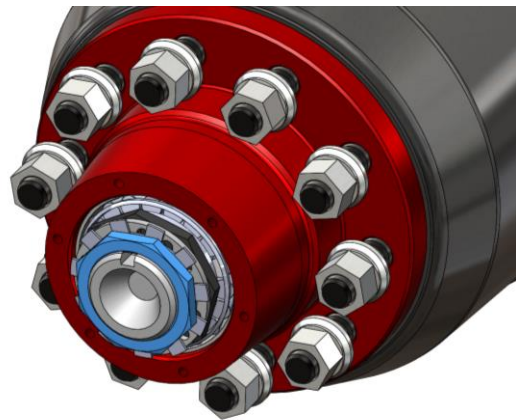
Straighten locking tab, then undo and remove locknut.

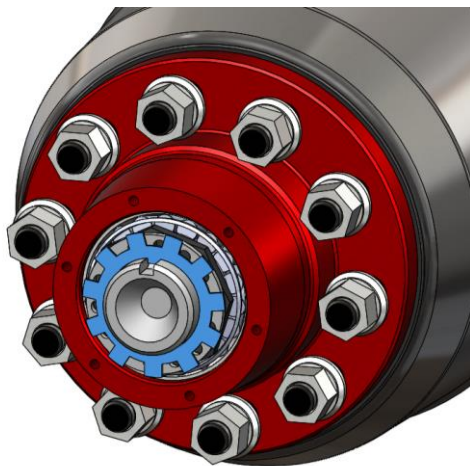
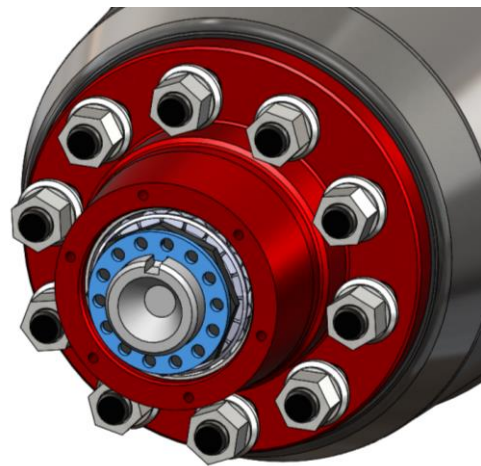
Then remove the tab washer and the lock washer.

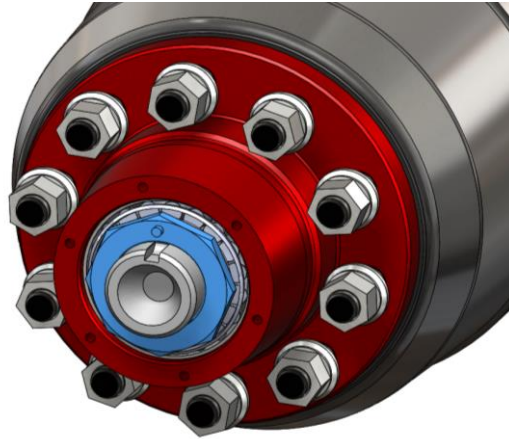
To replace the hub or drum then the wheel studs need to be pushed out. Use a hydraulic press to push the studs out of the hub & drum.

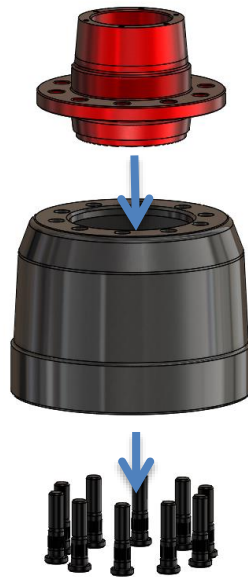
It is important to replace the wheel studs once they have been removed as there may be damage to the wheel stud splines.

Take care with the removal of hub as this will change the balance of the axle. It is advisable to use a hub puller if one is available.

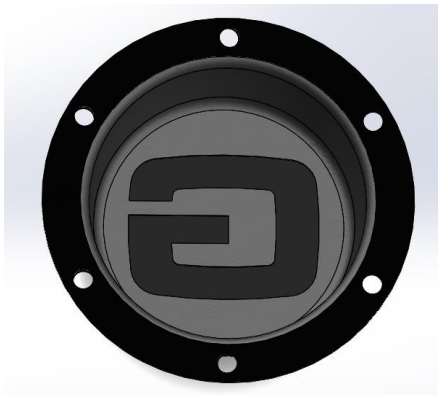
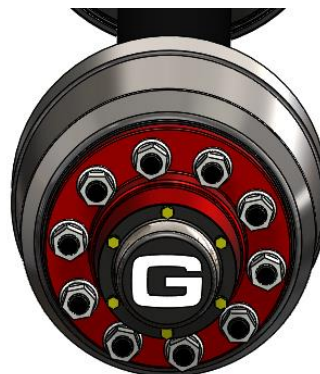
End float procedure when hub is fitted

- Fit the adjusting nut and torque to 373 Nm.
- Rotate the brake drum 4 times and re-torque to 373Nm.
- Loosen the adjusting nut by one full revolution.
- Torque the adjusting nut to 102Nm.

- Back off (Loosen) the adjusting nut 1 to 1.5 flats.
- Fit the lock washer so the dowel pin of the adjusting nut slides into one of the holes of the washer. If necessary flip the washer to achieve this alignment, or loosen half a hole.

- Fit the lock nut and torque it to 373Nm.
- Fold down two of the tabs on the lock washer, one at 12 o'clock and one 3 o'clock.
- Rotate the brake drum 4 times to test the functionality of the brakes.

- Manually rotate the camshaft and simultaneously rotate the drum to check.
- Clean the surface area of the end of the spindle.
- The above procedure is used to set the end float to be between 0.0254mm - 0.1016mm (1 - 4 thousandth inch). Ideally this should be confirmed using a dial gauge.

- Apply a small amount of grease to spindle end and hub cap. Fit the gasket and fit the hub cap bolts and torque to 20-25Nm.

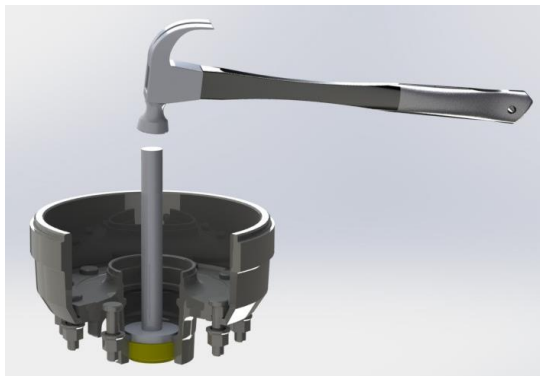
Outer bearing cone being removed.

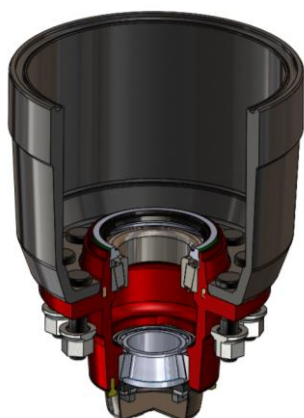
Before fitment remember to check that the bearing is fully pre-packed with grease. When fitting bearings it is essential to use proper tools that have been designed for the task. Using these tools will help to prevent damage to the bearing. Damaging a bearing on fitment could cause increased wear and premature failure. Ensure bearing cone and seal are fully seated in hub before reassembly.

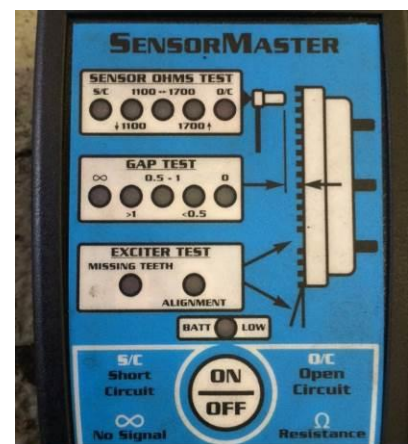
If the ABS pole wheel is being replaced or fitted, 80 tooth (Part no. 61787), it is important that it is fully seated on the hub and it is perfectly parallel to the hub face otherwise it will create an ABS fault reading. If replacing or changing the ABS sensor ensure it is properly coated with the supplied anti fretting paste.

Anytime an ABS axle is serviced the axle should be tested with an ABS testing device when reassembled.
