Axle Service Manual

960 Series Drum Brake 10 spline

Internal /External Drum, 420mm x 180mm

80263 REV B

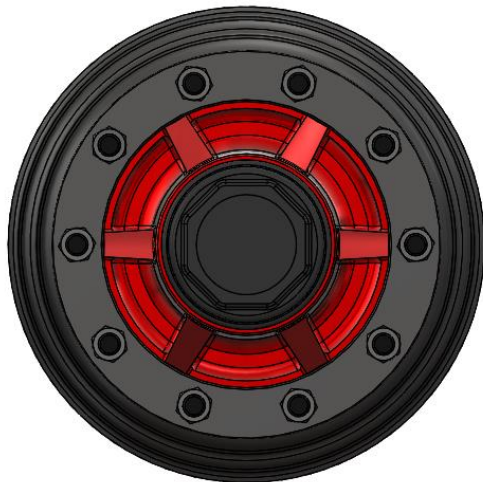
Undo the Hub cap

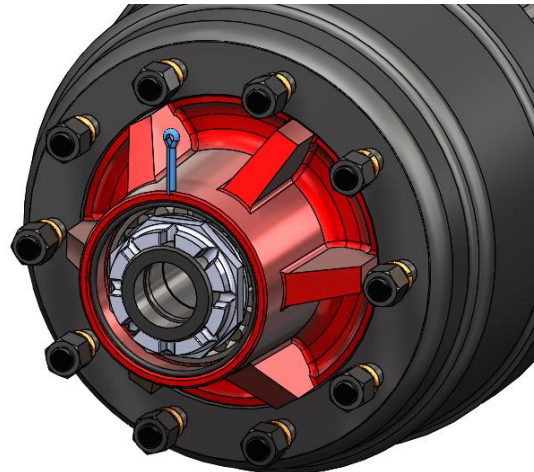
Straighten cotter pin tab's & remove it

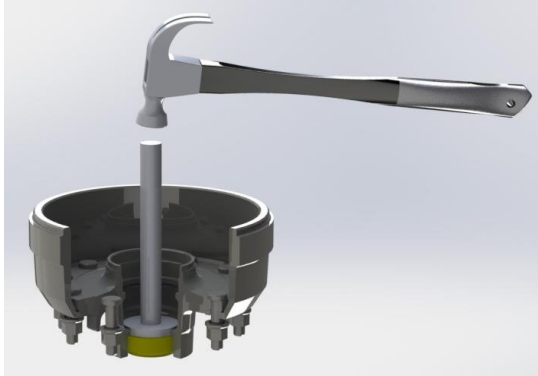
Outer bearing cone being removed.

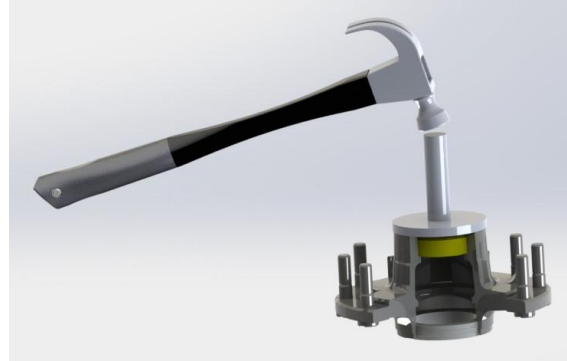
Outer bearing cone being fitted

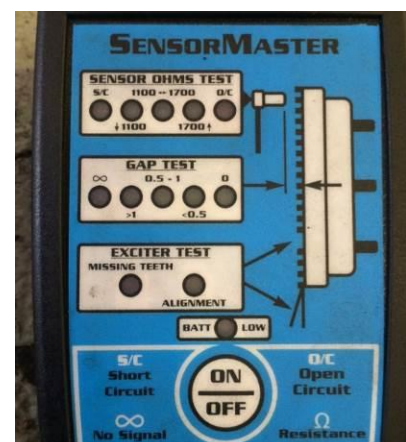
If the ABS pole wheel is being replaced or fitted, it is important that it is fully seated on the hub and it is perfectly parallel to the hub face otherwise it will create an ABS fault reading. If replacing or changing the ABS sensor ensure it is properly coated with the supplied anti fretting paste.

Anytime an ABS axle is serviced the axle should be tested with an ABS testing device when reassembled.
