## **Axle Manual**

### **750 Series Drum Brake**

*300mm x 135mm*

*Updated: October 2020  
80279 REV C*

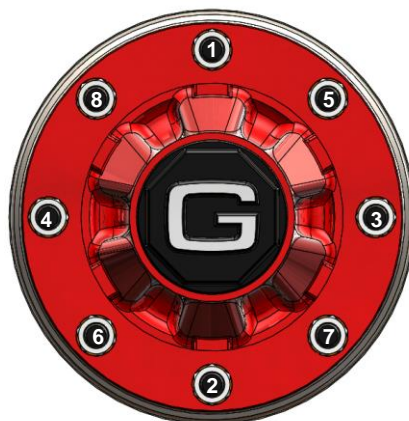
To achieve correct tension in each of the wheel locating bolts, and thus optimum wheel security, Tighten wheel nuts in the order shown below.

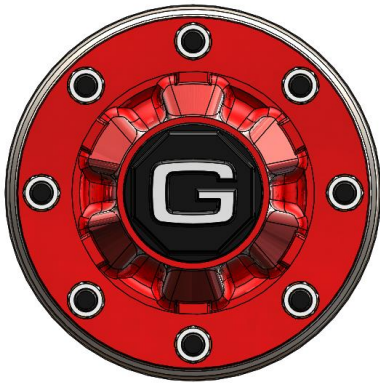
Hub cap is removed

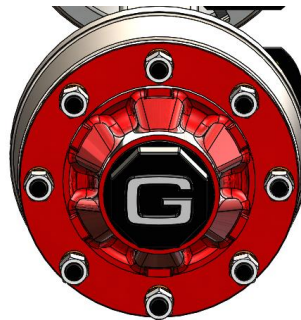
- Apply a small amount of grease to spindle end and hub cap. Fit the gasket and fit the hub cap with a rubber mallet.

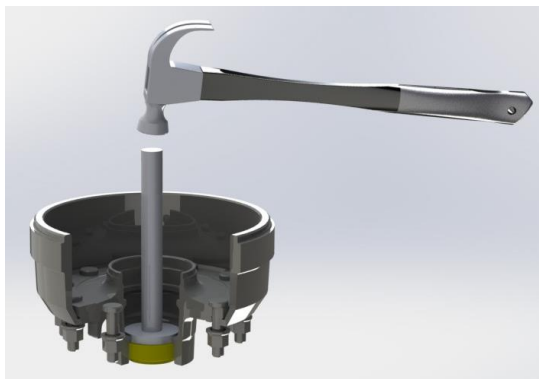
Outer bearing cone being removed.

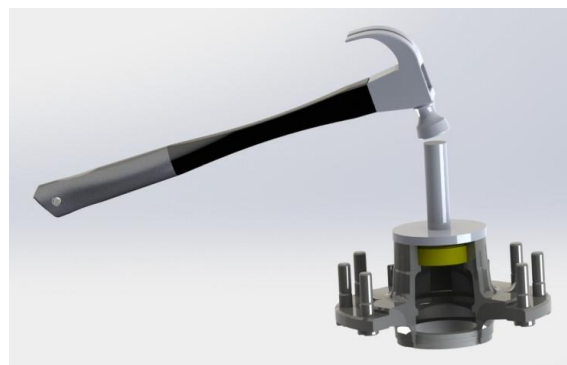
Outer bearing cone being fitted

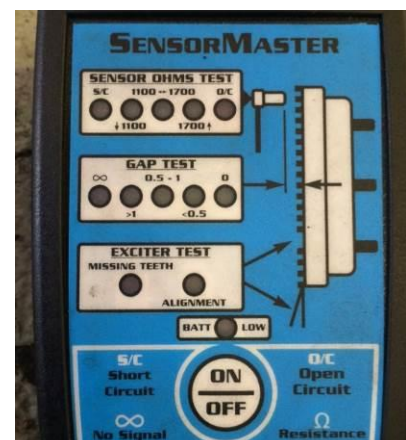
If the ABS pole wheel is being replaced or fitted, 80 tooth (Part no. 61789), it is important that it is fully seated on the hub and it is perfectly parallel to the hub face otherwise it will create an ABS fault reading. If replacing or changing the ABS sensor ensure it is properly coated with the supplied anti fretting paste.
